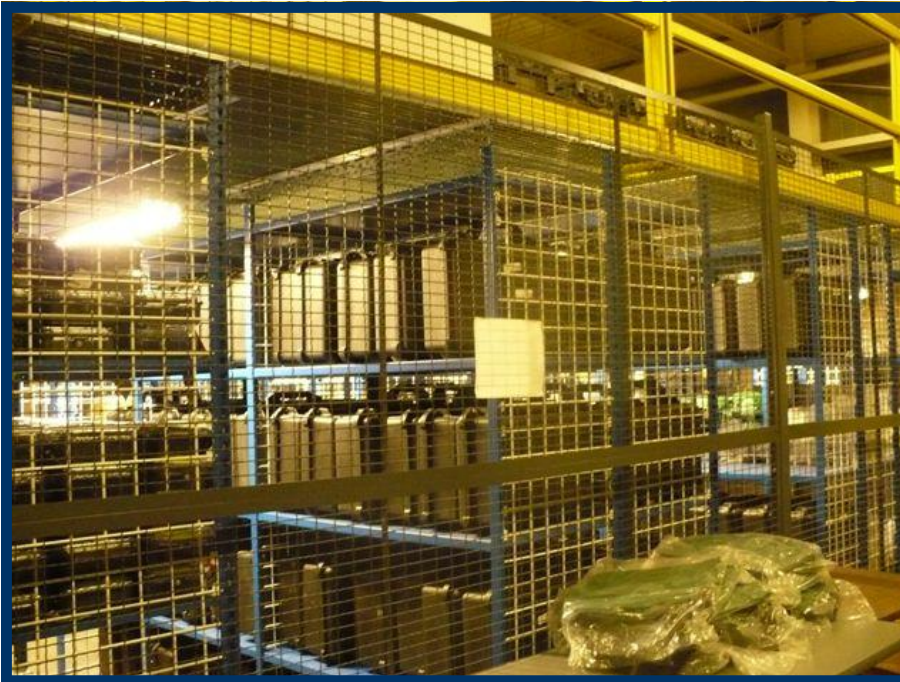
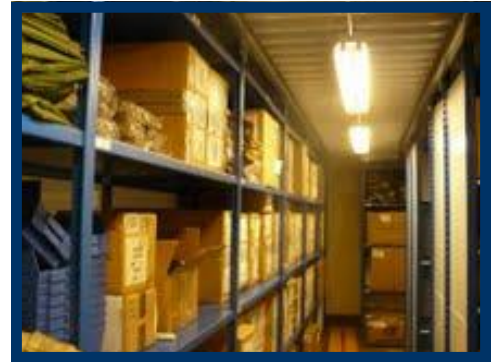
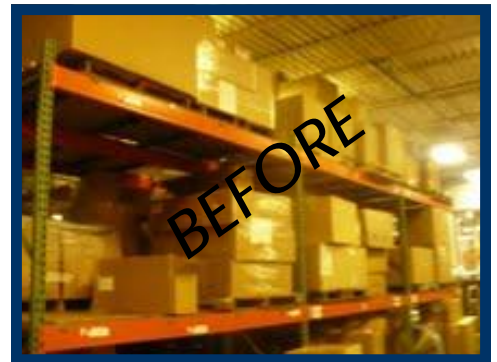
PeakLogix recommended for each area a shelf-supported mezzanine with 48"x36", 18"x36", and 24"x48" shelving. One area had solid shelving and a closed back and sides, while the other was constructed of wire. Each included a lockable wire cage with separate keys for security, and the two areas were made secure with separate mezzanine entrances. New lighting was also recommended, with wire guards to eliminate damage and hazards.

The shelf-supported mezzanine was installed, tripling the usable space. Shelving below the mezzanine provides better visibility, accountability, and security. The client now has secure space for overflow and room to grow.

- Total area not to exceed 55'x56' and 3080 square ft.
- 7' tall solid and wire shelving were requested: one area required ventilation; the other did not.
- Each area needed to be separate and secure from the other.
